# BRIDGE INSPECTION REPORT

## Routine Inspection

BRIDGE NO.:  
**10C0146**

STRUCTURE NAME:  
**ROBINSON CREEK**

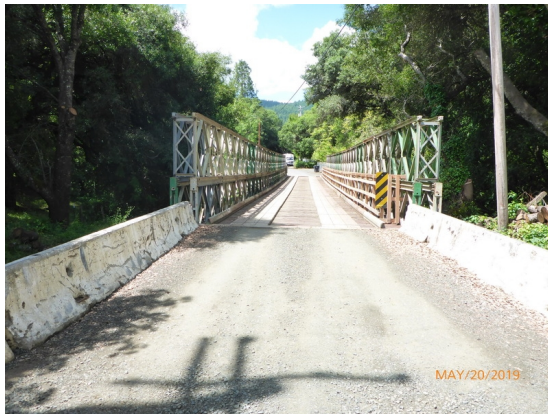
Routine-Roadway View (05/20/2019)

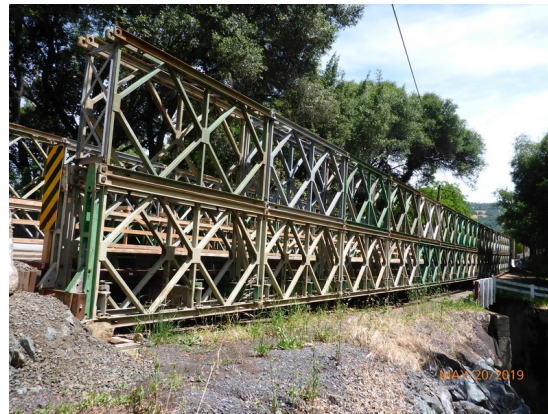
Routine-Elevation View (05/20/2019)

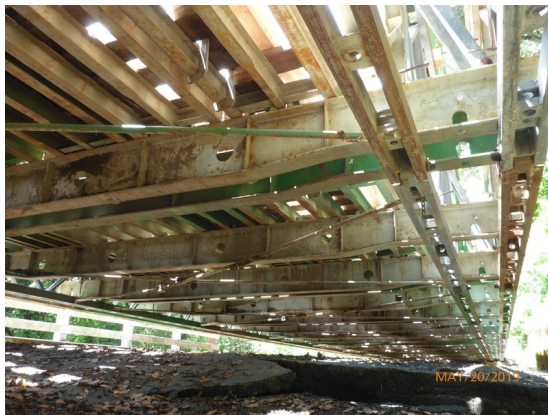
Routine-Underside View (05/20/2019)
