# BRIDGE INSPECTION REPORT

## Routine Inspection

BRIDGE NO.:  
**10C0095**

STRUCTURE NAME:  
**RANCHERIA CREEK**

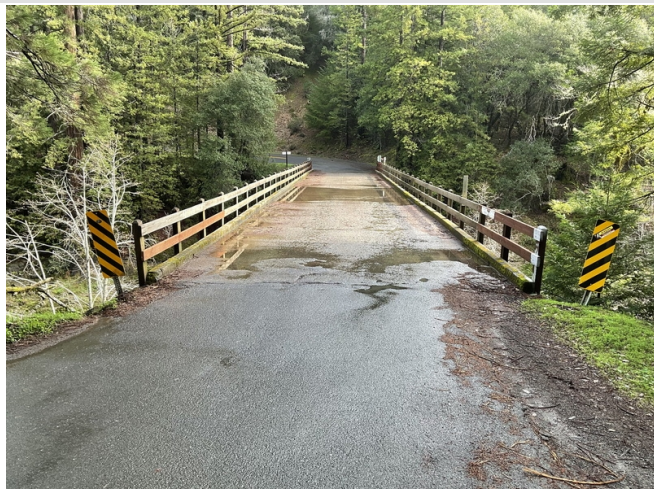
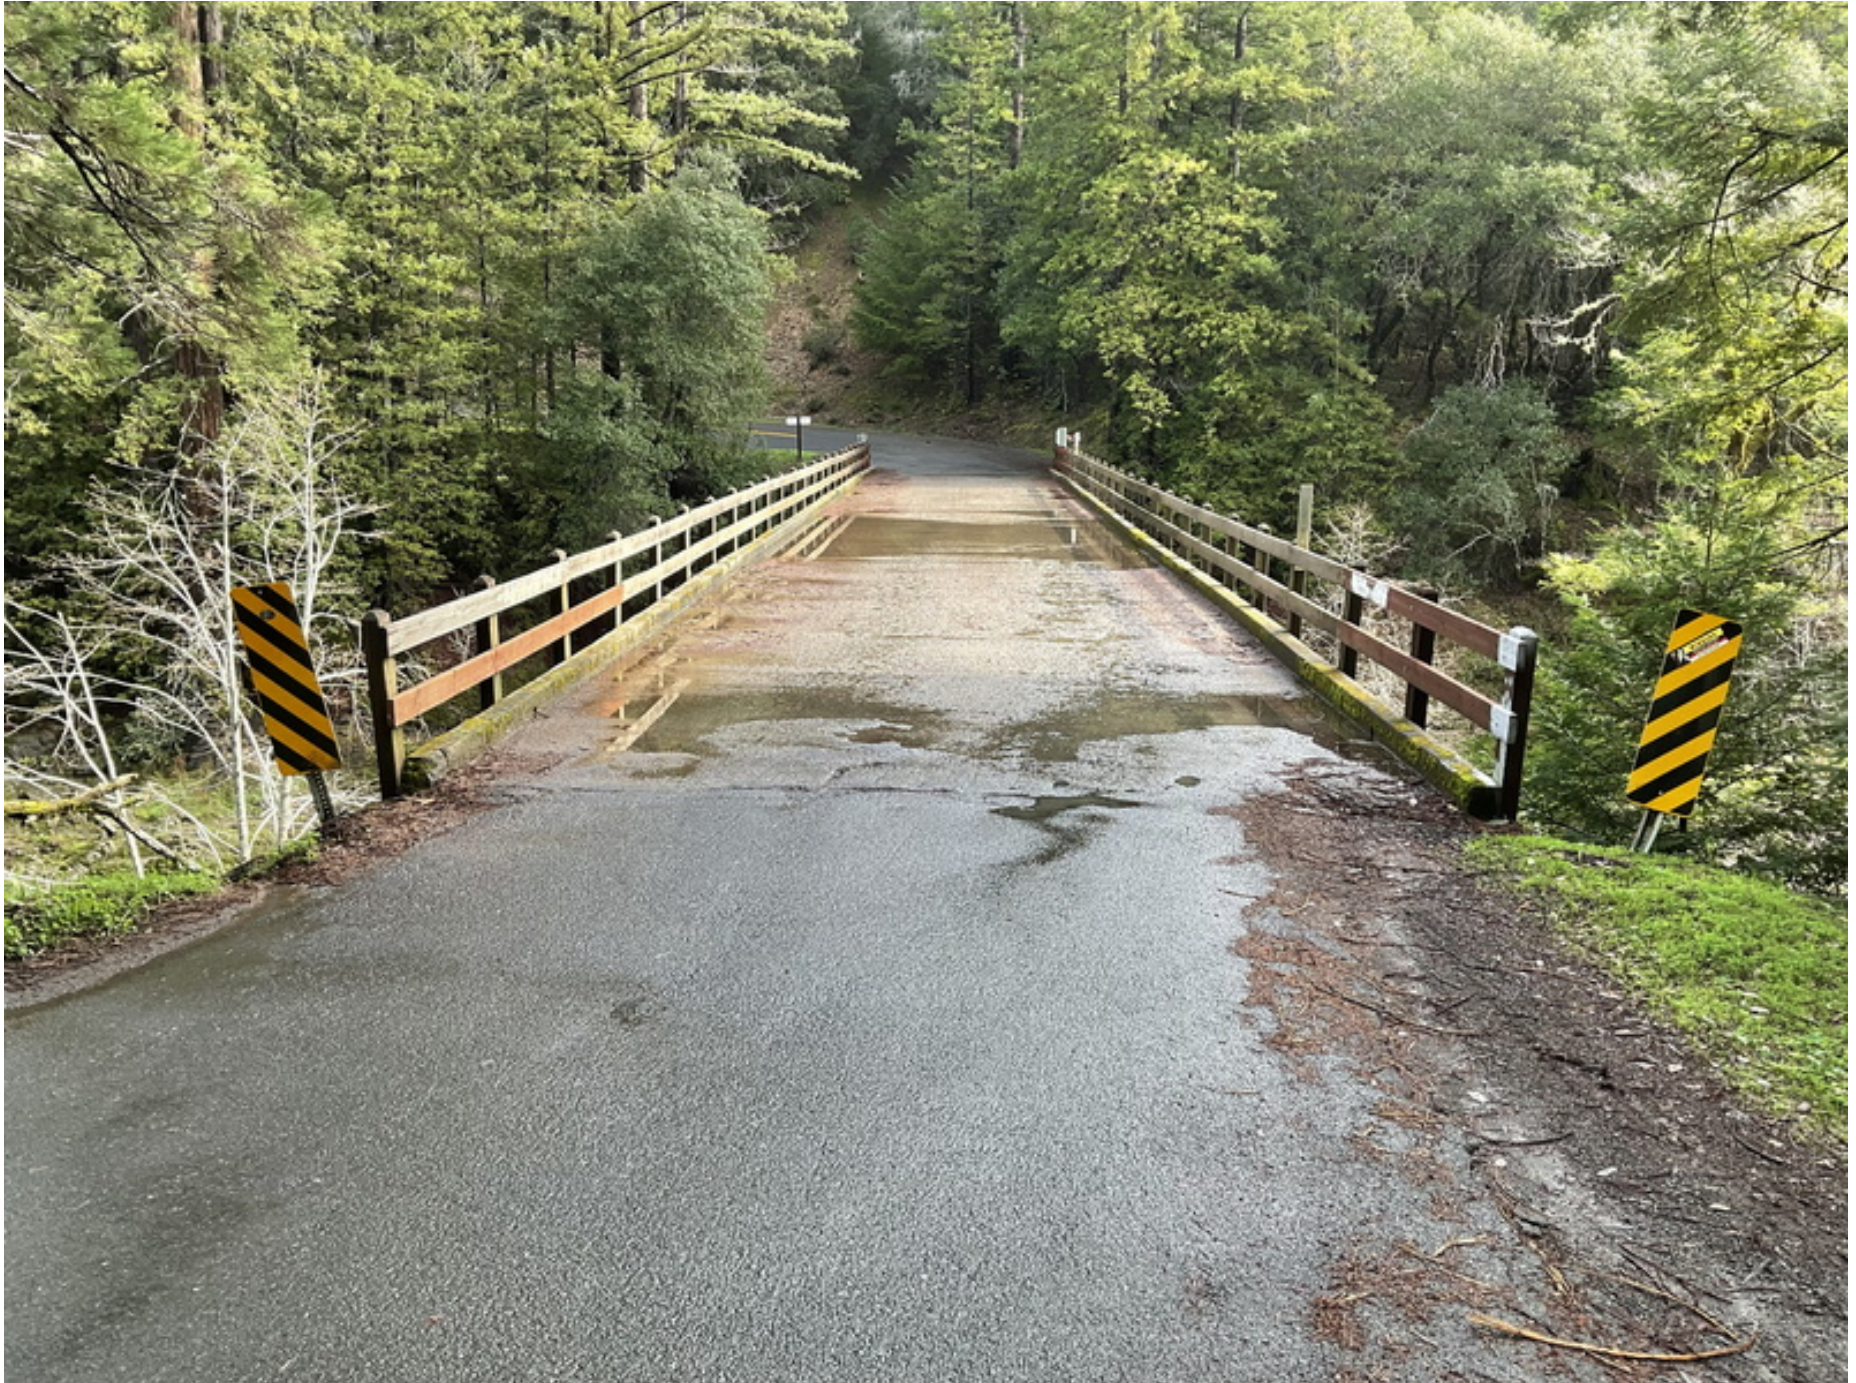
Photo #1

Photo 1  
Roadway view taken from Abutment 1.

Roadway view taken from Abutment 1.

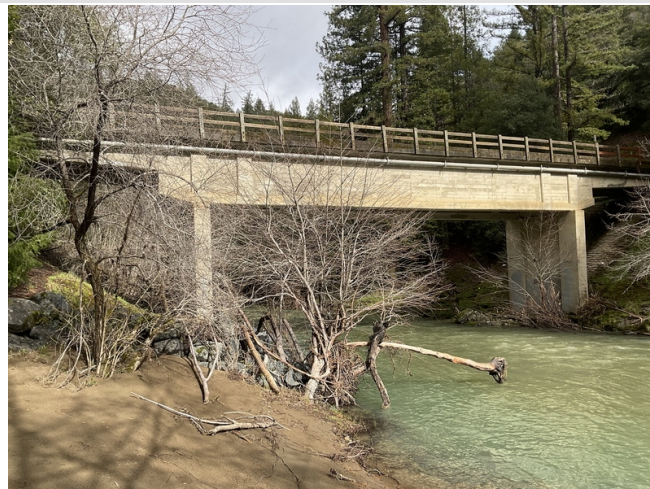
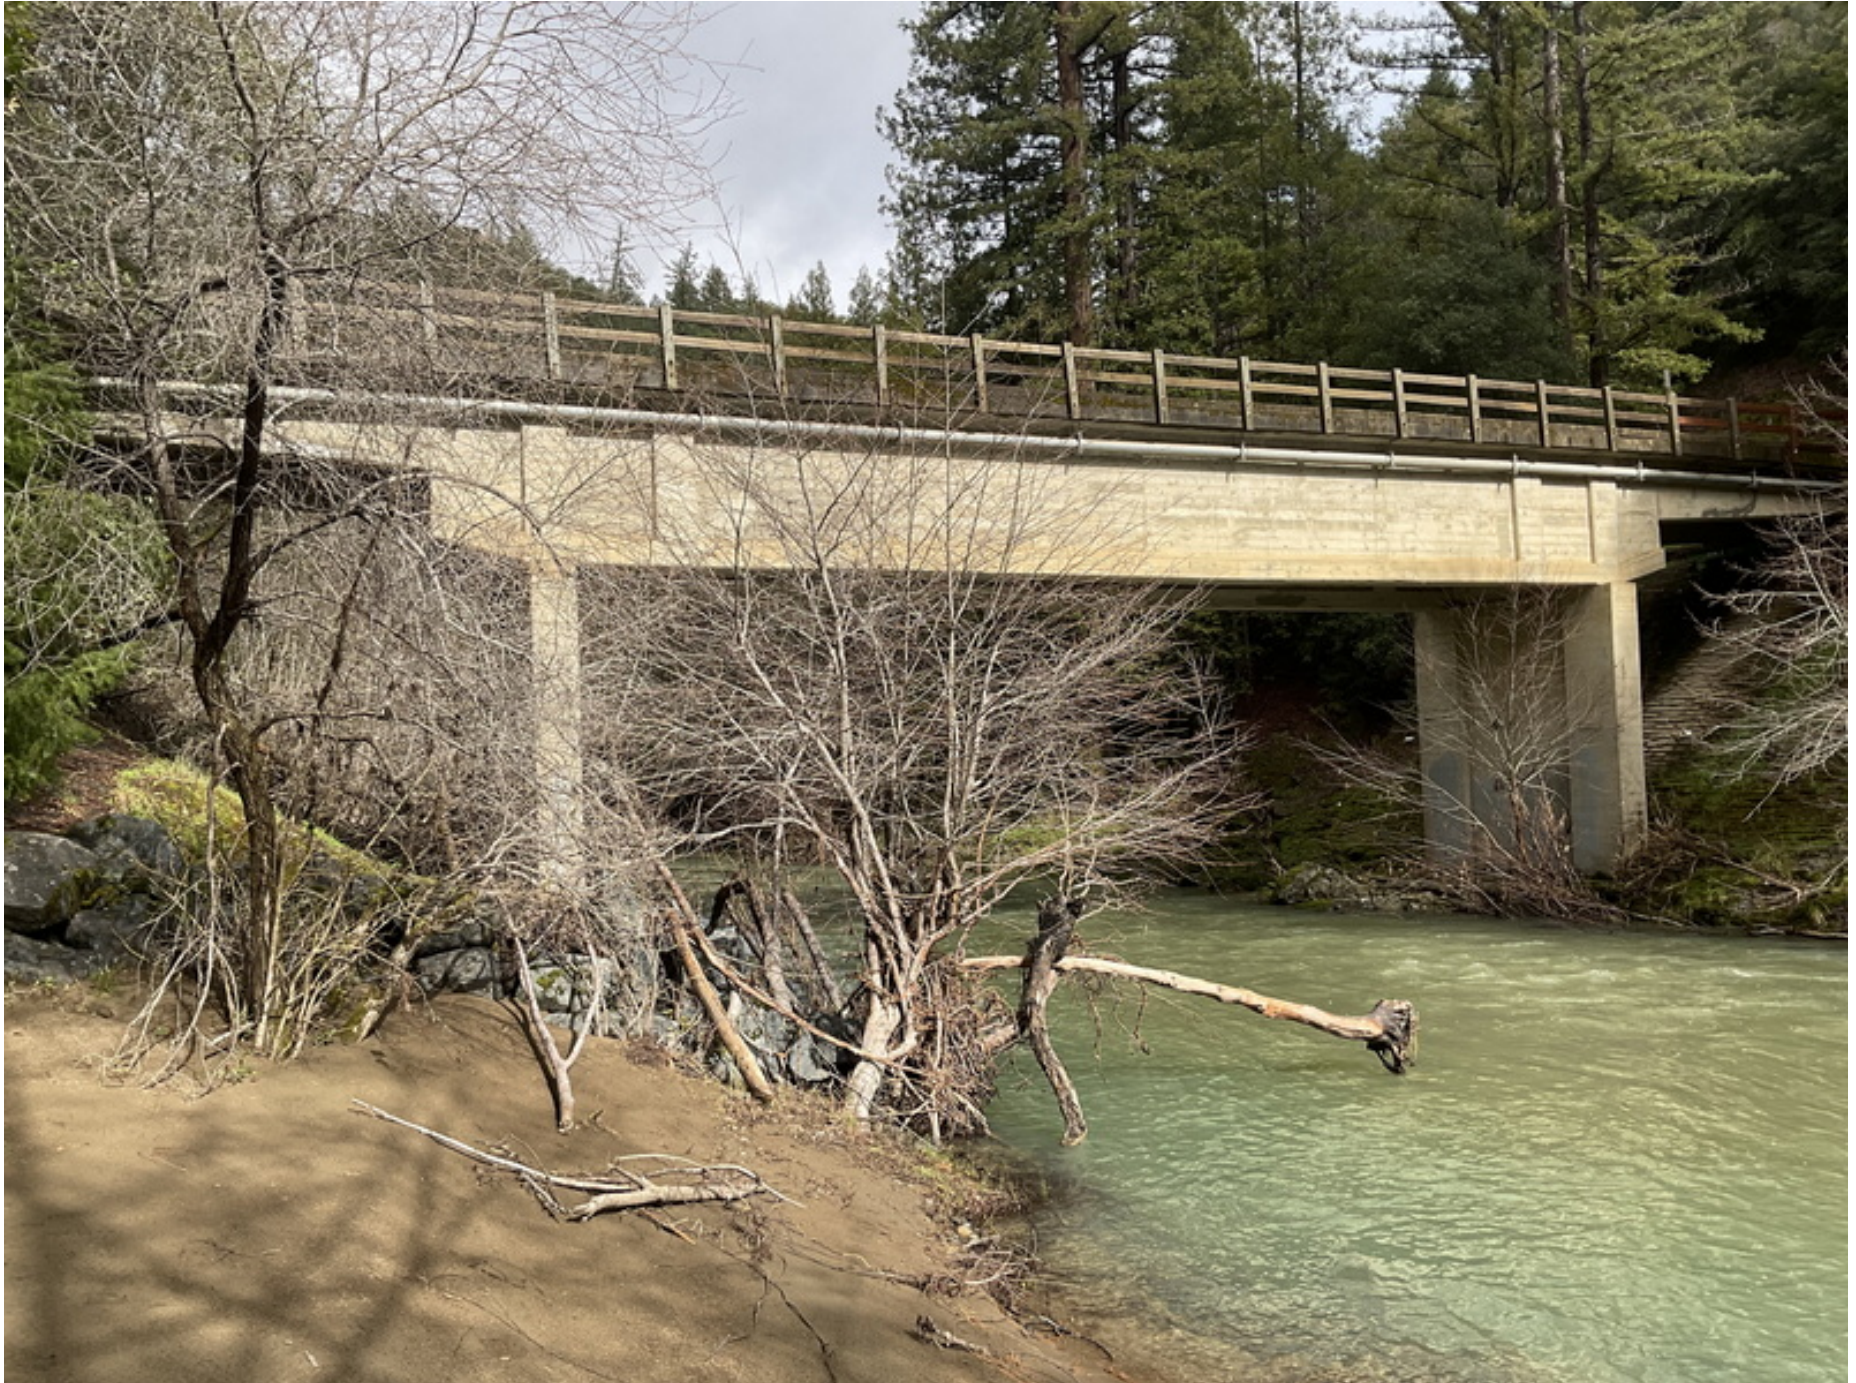
Photo #2

Photo 2  
Elevation view taken from the right side of the bridge.

Elevation view taken from the right side of the bridge.

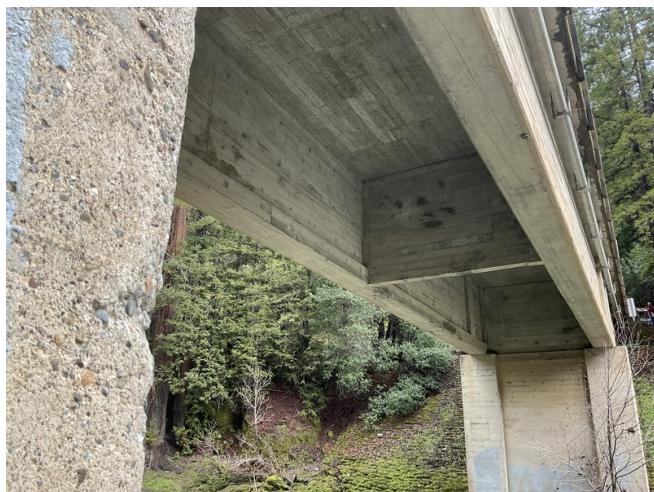
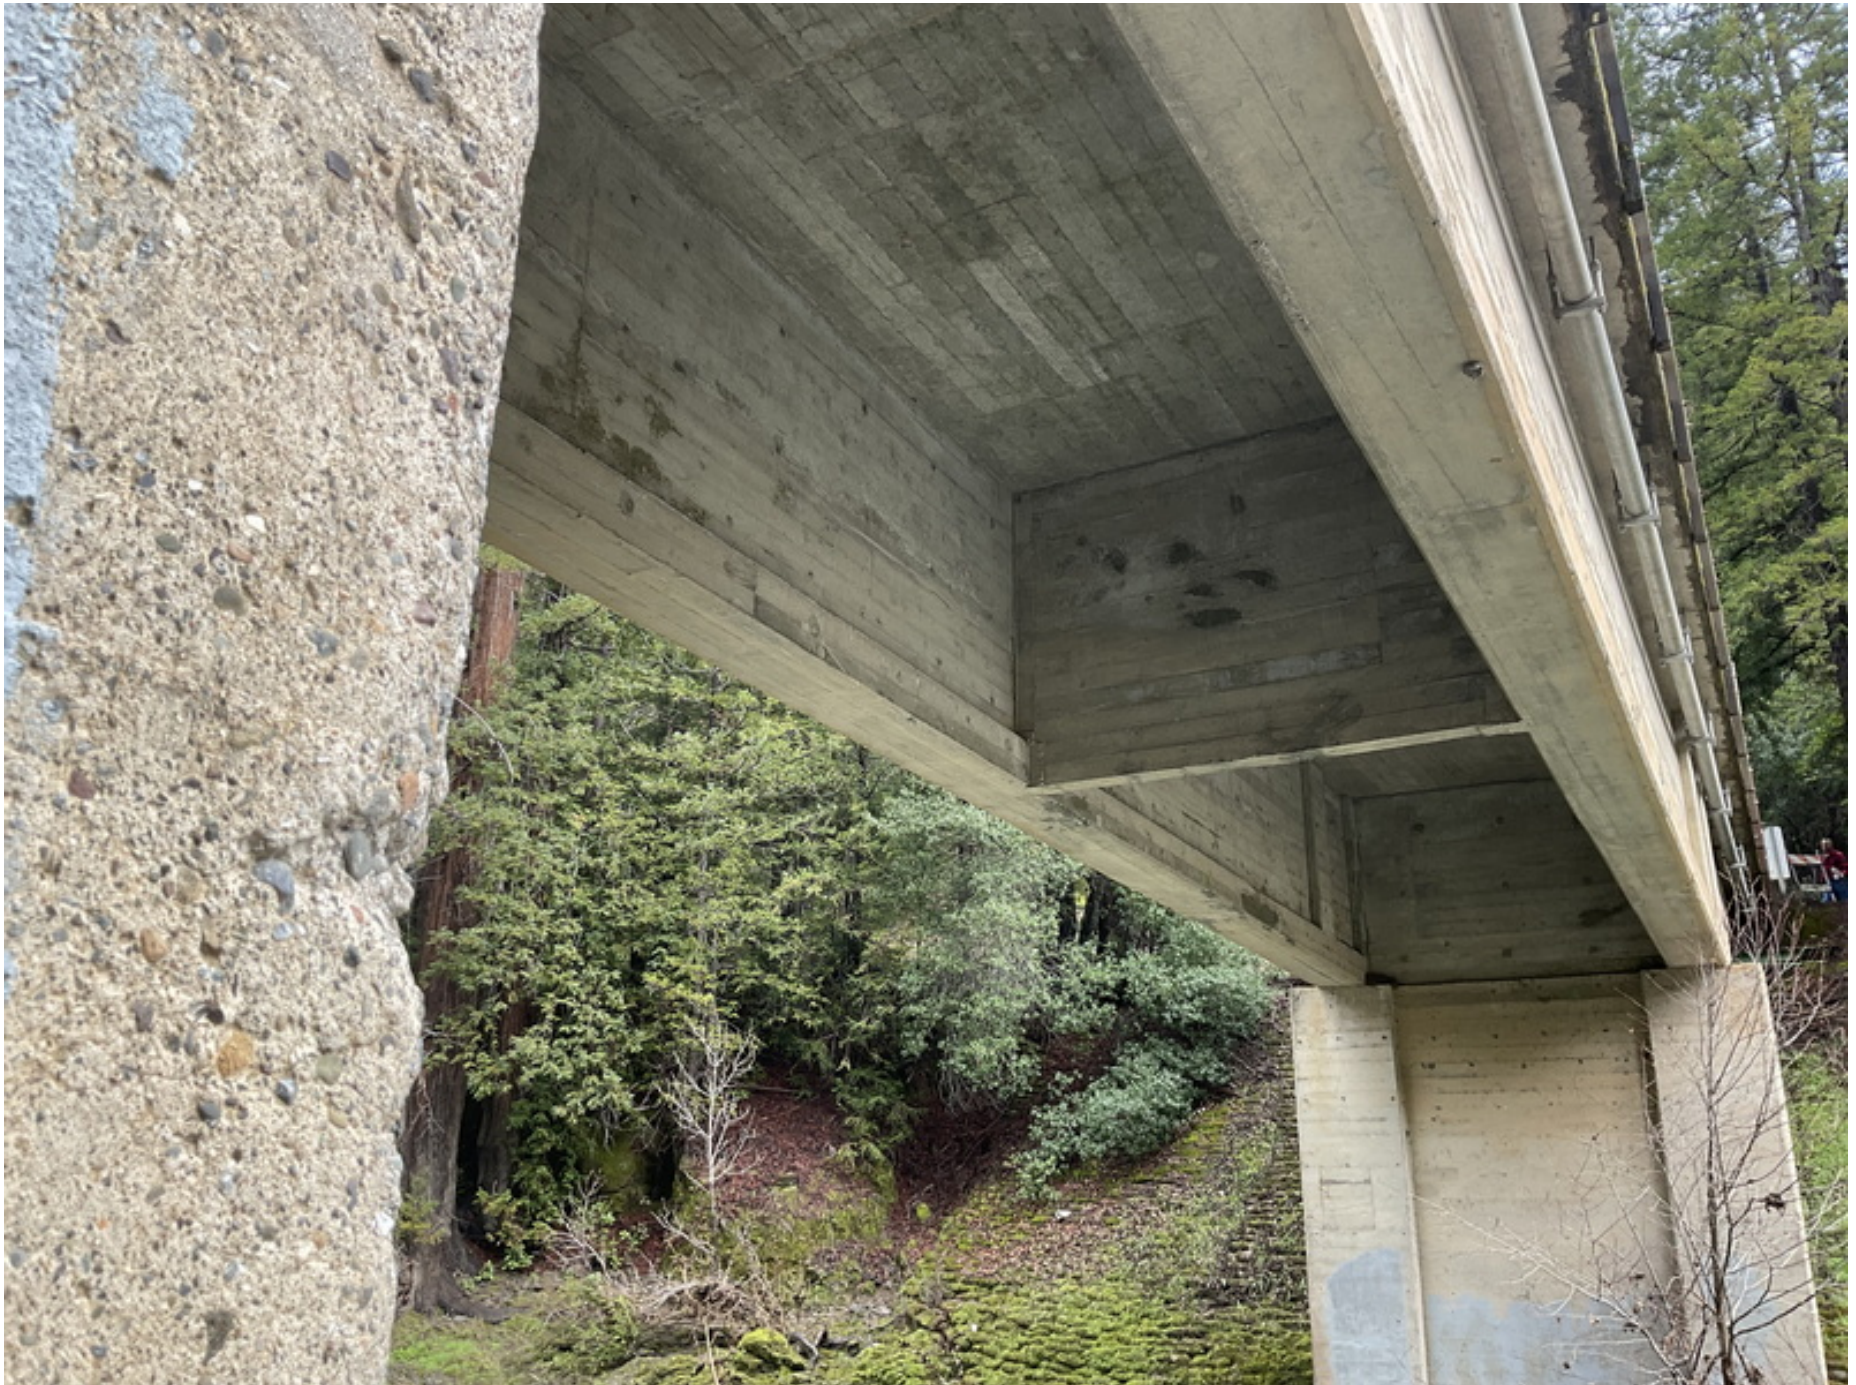
Photo #3

Photo 3  
Underside view of Span 2 taken from the right side of Pier 2.

Underside view of Span 2 taken from the right side of Pier 2.
