# ROBINSON CREEK BRIDGE REPLACEMENT ON LAMBERT LANE

## Natural Environment Study

Bridge No. 10C0146

## **Robinson Creek Channel Design Report for the Lambert Lane Bridge Replacement Project**

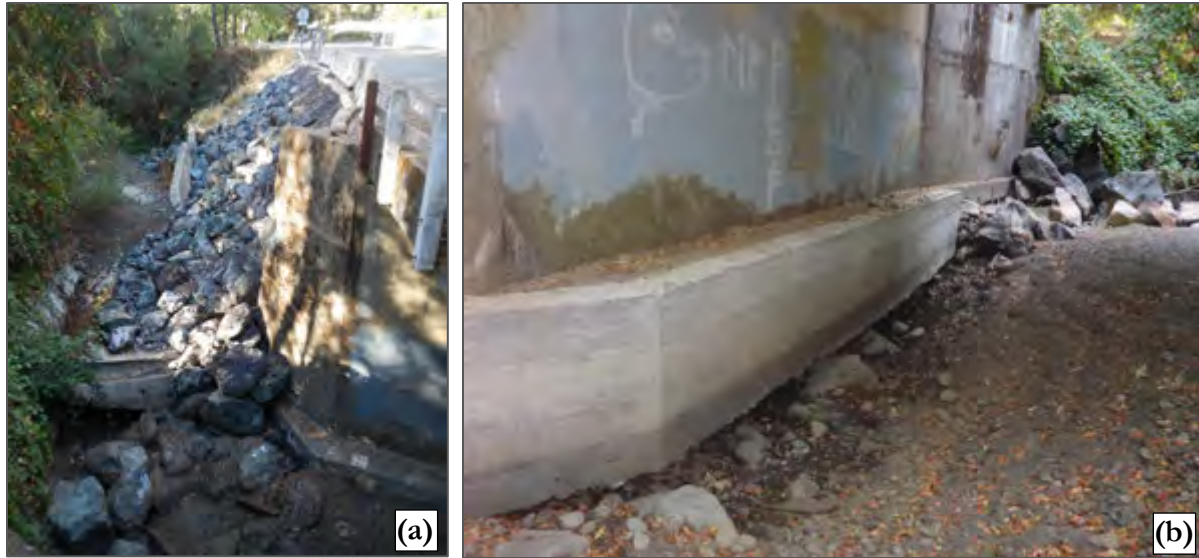
**Figure 2. Current condition of the channel at the Lambert Lane Bridge, with (a) riprap placed along roadway embankment at location of collapsed retaining wall and (b) a new concrete skirt along the undermined footing.**

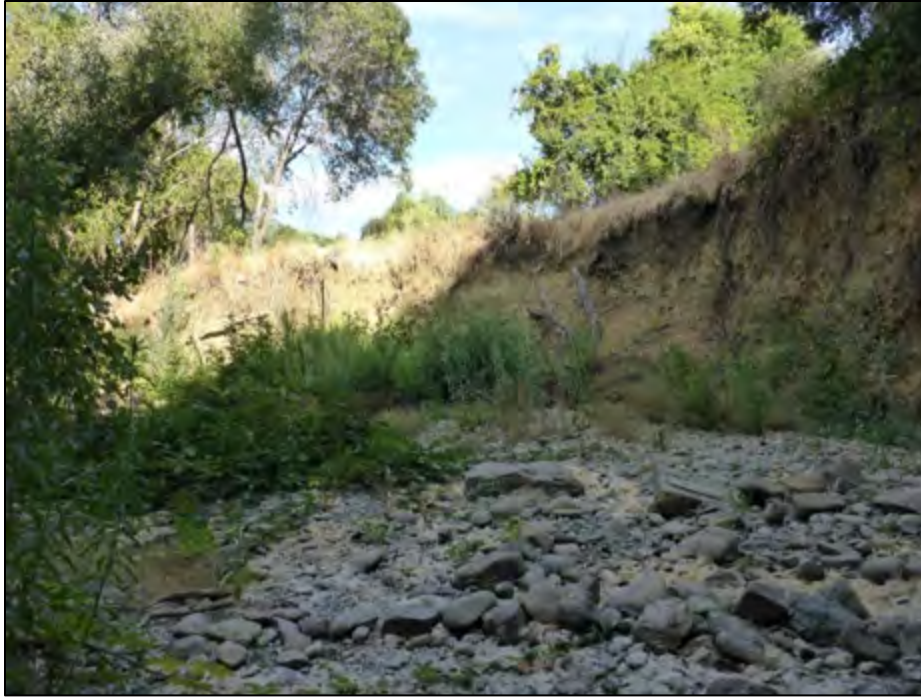
**Figure 5. Looking downstream at the active bank failure and local sediment aggradation upstream of large wood jam, 150 feet downstream of the Lambert Lane bridge (near station 27+50).**

Immediately downstream of the bridge there is a tight left bend in the channel. The bank along the outside of the bend located on the property of the Boonville Hotel is oversteepened and actively eroding (Figure 5). The resulting bank failures have toppled numerous mature trees into the channel, creating a large wood jam near station 28+00. This bank failure started in 2012 with the loss of a heritage oak tree (personal communication, Linda MacElwee, RCD), but became more extensive during the winter of 2017. Between the 2016 and 2018 surveys, the height of the channel bed upstream of the large wood jam aggraded approximately 1.6 feet.

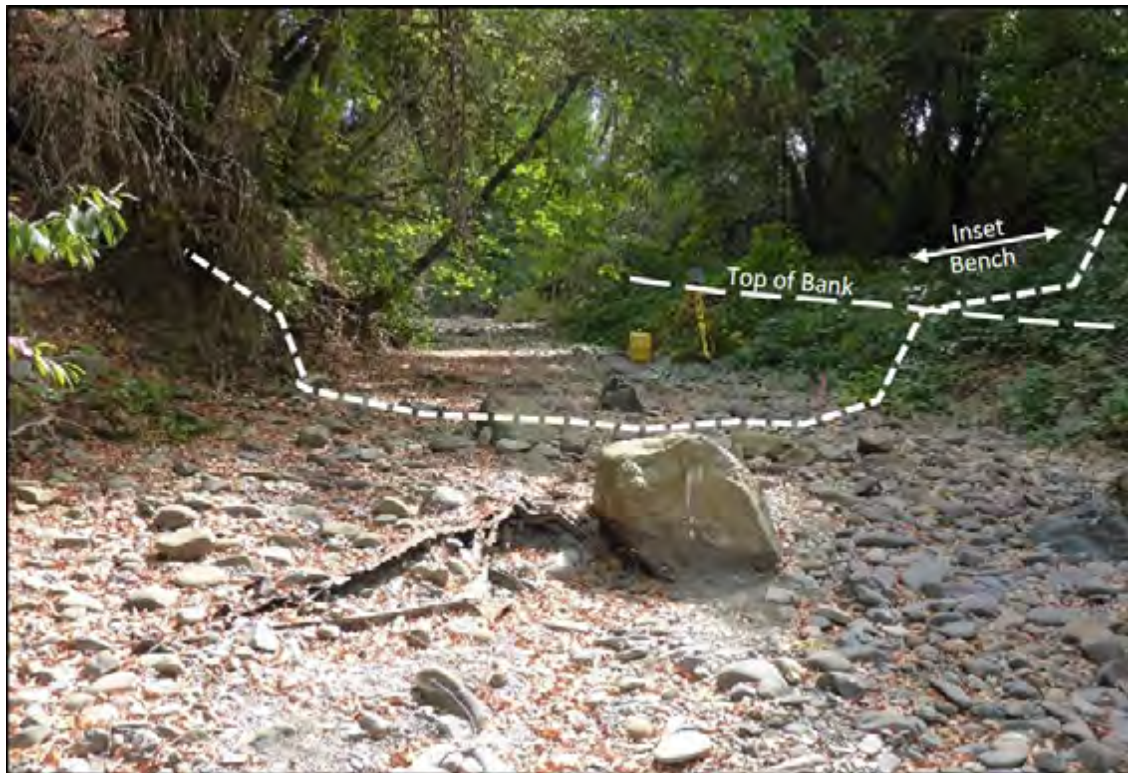
**Figure 7. Looking upstream at selected reference reach, with typical channel cross section and location of inset floodplain bench noted.**

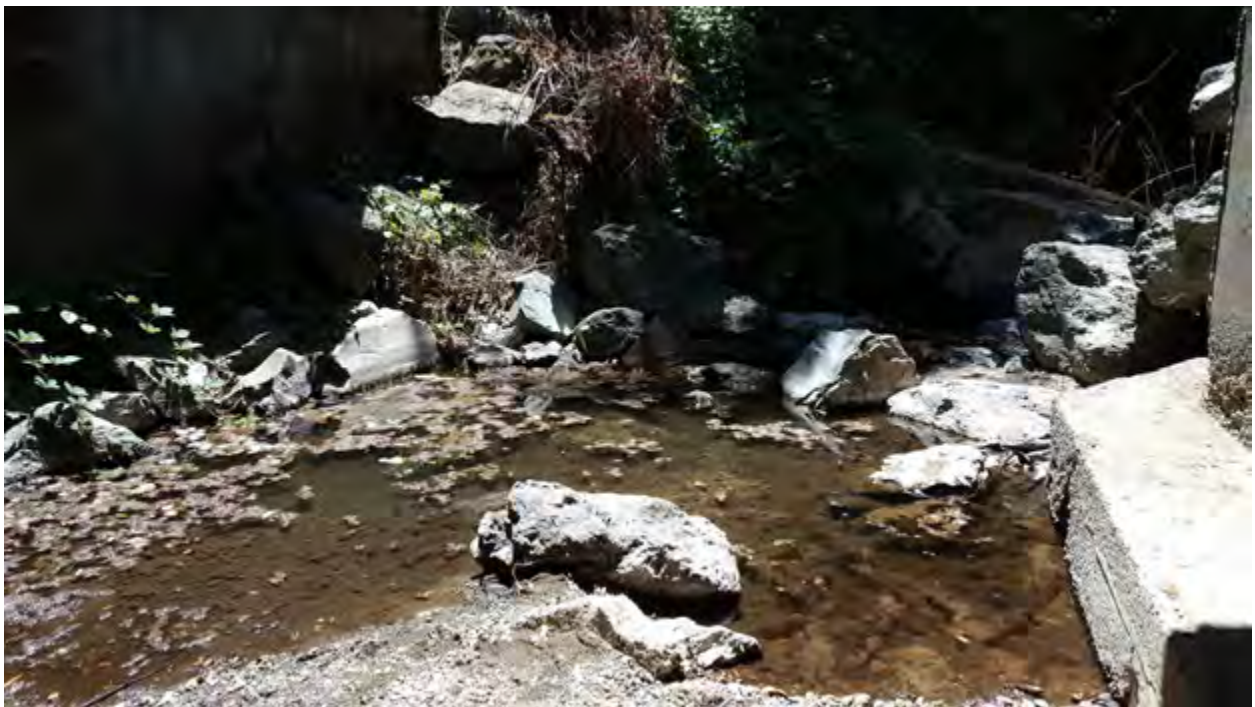
Looking southeast immediately upstream of the bridge at ponded water with algae bloom. The start of the failed retaining wall and RSP that are acting as a fish passage barrier can be seen on the right.

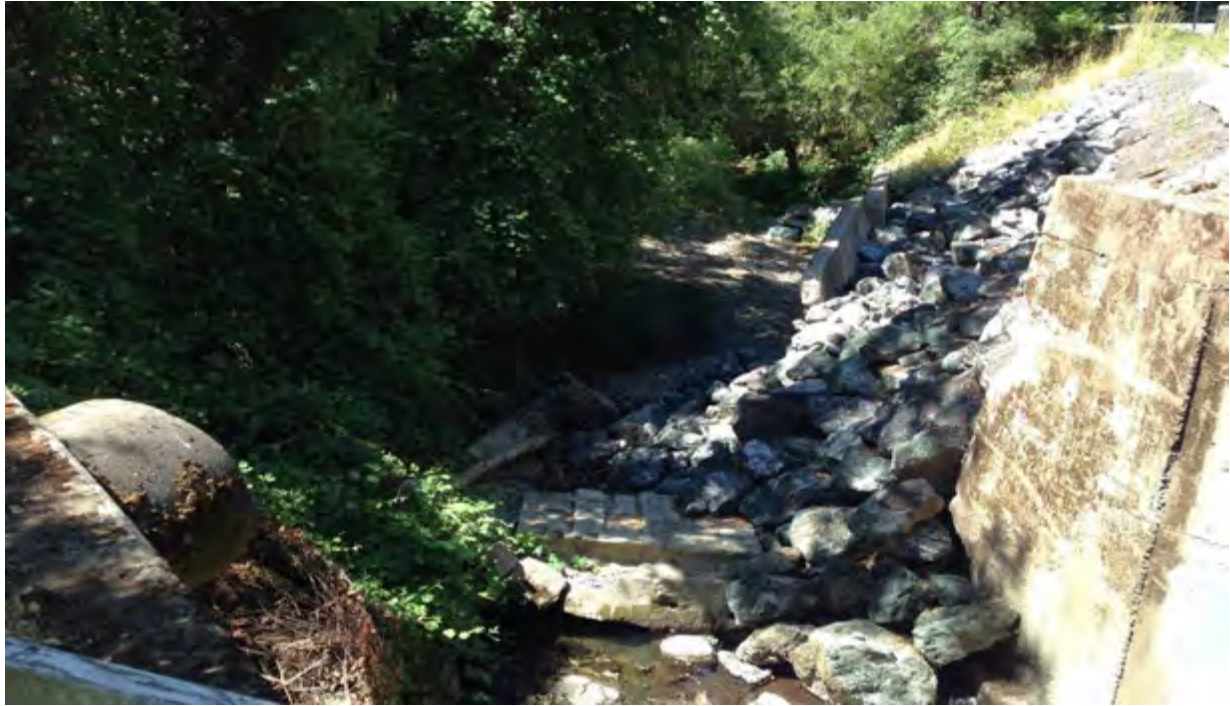
Standing on the northwest corner of the bridge looking west at the failed retaining wall and RSP.
