***Robinson Creek Bridge Replacement of Lambert Lane***

## Natural Environment Study

Bridge No. 10C0146

## **Robinson Creek Channel Design Report for the Lambert Lane Bridge Replacement Project**

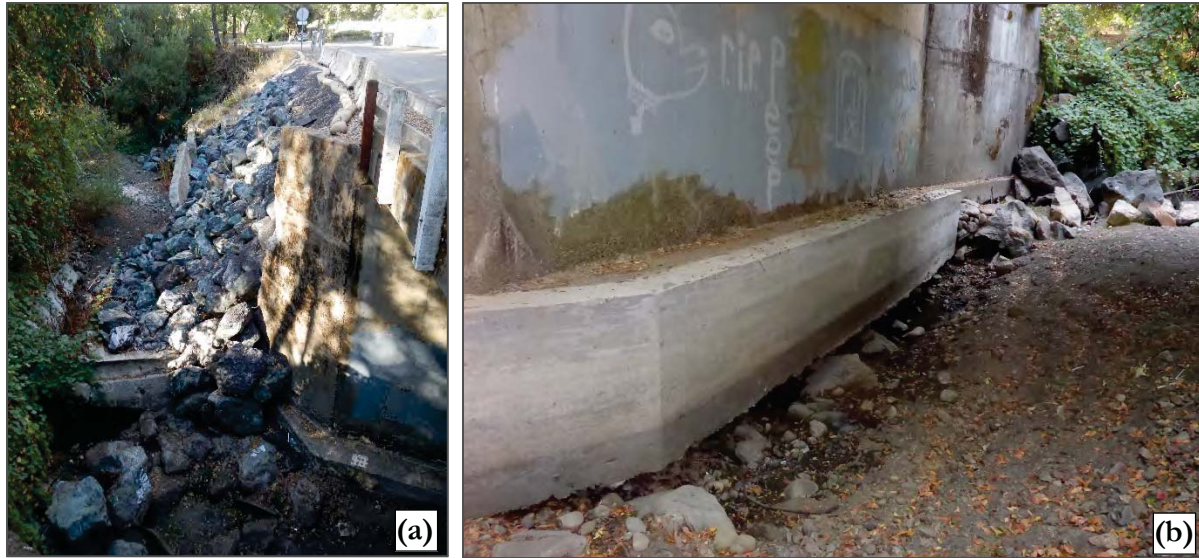
**Figure 2. Current condition of the channel at the Lambert Lane Bridge, with (a) riprap placed along roadway embankment at location of collapsed retaining wall and (b) a new concrete skirt along the undermined footing.**

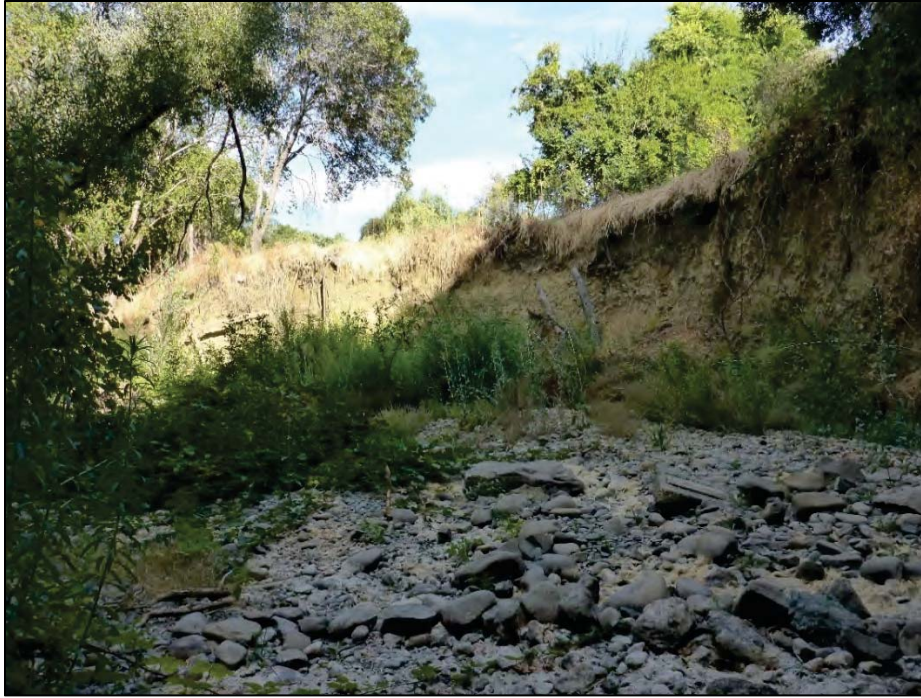
**Figure 5. Looking downstream at the active bank failure and local sediment aggradation upstream of large wood jam, 150 feet downstream of the Lambert Lane bridge (near station 27+50).**

Immediately downstream of the bridge there is a tight left bend in the channel. The bank along the outside of the bend located on the property of the Boonville Hotel is oversteepened and actively eroding (Figure 5). The resulting bank failures have toppled numerous mature trees into the channel, creating a large wood jam near station 28+00. This bank failure started in 2012 with the loss of a heritage oak tree (personal communication, Linda MacElwee, RCD), but became more extensive during the winter of 2017. Between the 2016 and 2018 surveys, the height of the channel bed upstream of the large wood jam aggraded approximately 1.6 feet.

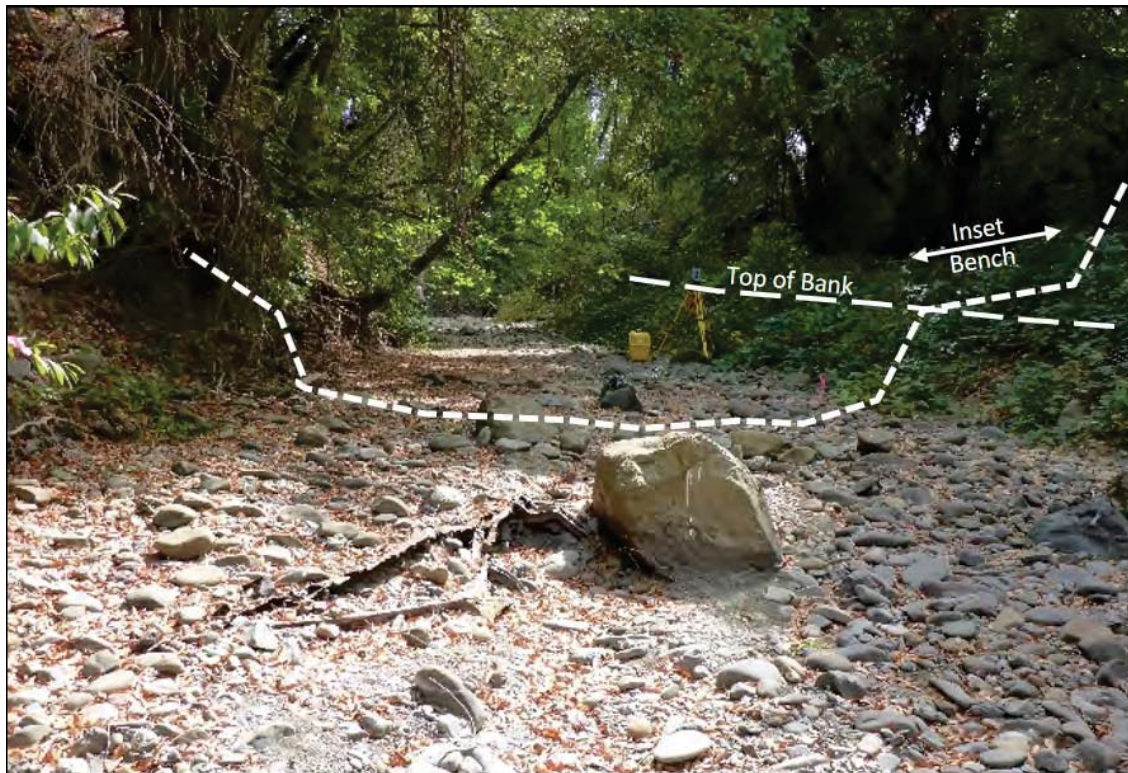
**Figure 7. Looking upstream at selected reference reach, with typical channel cross section and location of inset floodplain bench noted.**

The floodplain benches do not appear to be formed through deposition from overbank flows in the stream. Instead, they may be remnants of the historical channel bed prior to an incision event, as suggested by Florsheim (2006). As such, their inundation may not coincide to frequently occurring flows.
